TECHNICAL REPORT D-77
July 1977

FORT LEE ENLISTED PERSONNEL DINING FACILITY
MODERNIZATION EVALUATION PROGRAM

by
J. H. Burgess

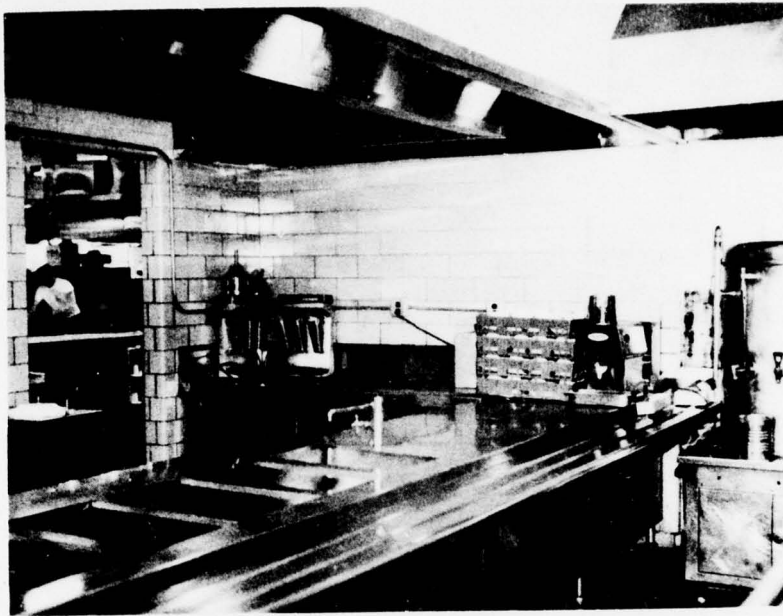
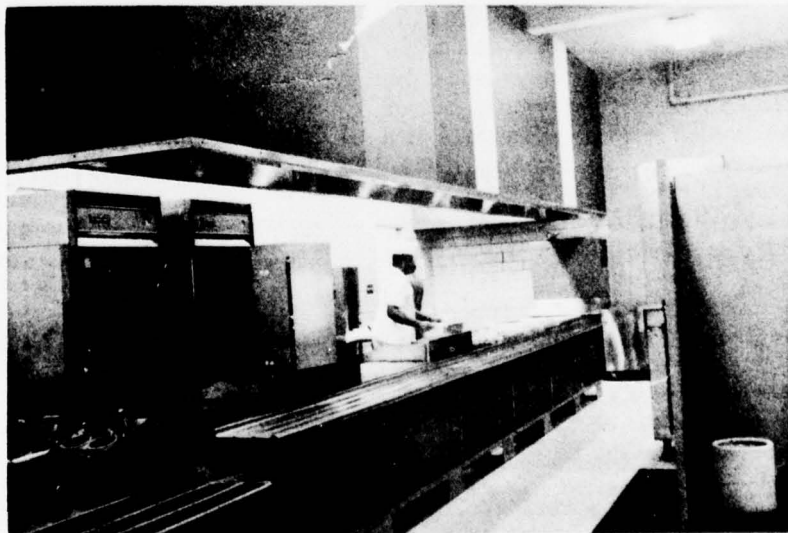
Figure 1. Food serving line.

a. Prerenovation

b. Postrenovation

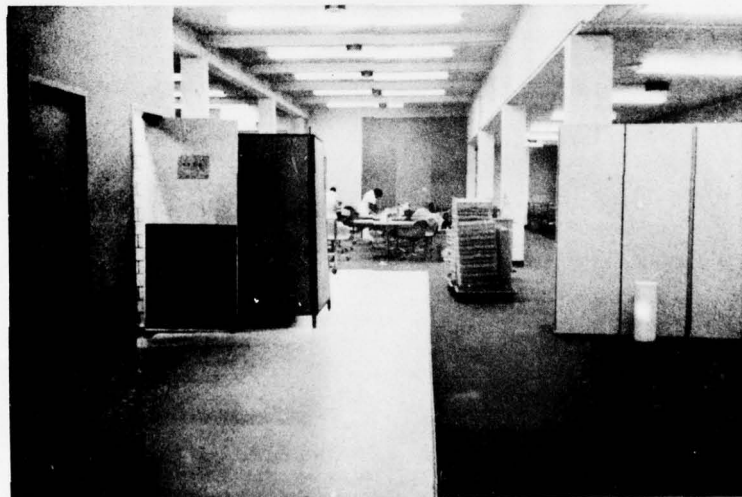
Figure 3. General view.

a. Prerenovation

b. Postrenovation

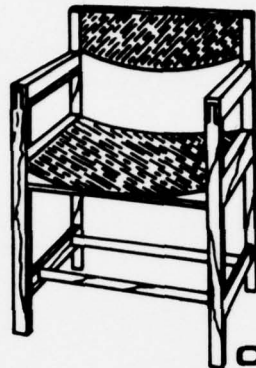
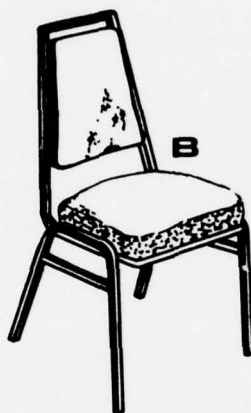
Figure A1. Tables and chairs.

CHAIR, SIDE ARM

CHAIR, STACK SIDE

CHAIR, CAPTAIN'S

CHAIR, SWIVEL SIDE

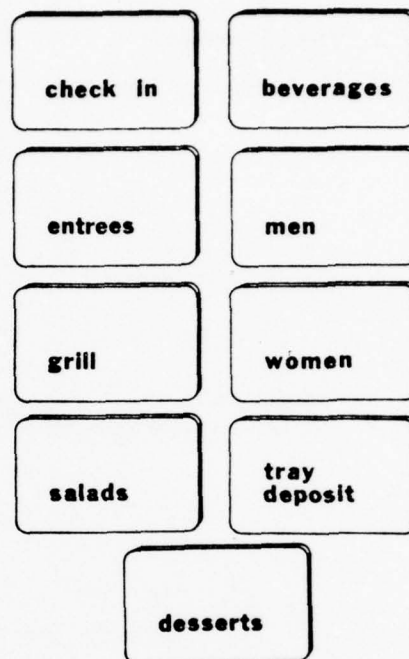
a. Signs AO343LN, 7 3/8 in. H X 23 13/16 in. W (25.7 cm X 60.3 cm), 2-in. (5.1 cm) letters, ordered in boxes of two (Herman Miller-Commercial).

b. Signs AO342LN, 7 3/8 in. H X 11 13/16 in. W (25.7 cm X 34.8 cm), 7/8 in. (2.3 cm) letters, ordered in boxes of five (Herman Miller-Commercial).
